SUBJECT: **Service Strike**

ISSUE DATE: **Dec 2019** **REF:** **HSB158**

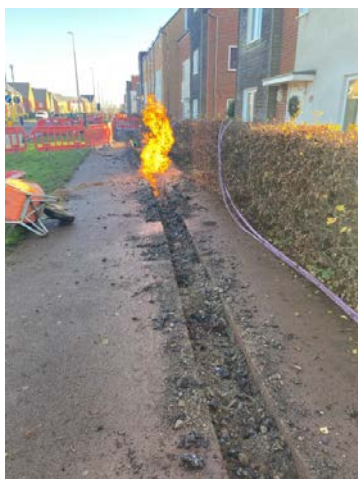
It was reported an incident had happened involving a combined gas and electric strike. This resulted in the ignition of the gas. The emergency services were called to support in the incident. The Gas provider made the area safe, no injuries were reported and the road was closed as a precaution whilst the repair was made. The cables were lowered, trench backfilled and area made safe with full reinstatement undertaken the following morning.

The strike was on both Electric - 35mm & Gas – 25mm service connections to a property. The services had been laid in a combined utilities trench. There were no safety indicative markers such as tiles or tape present in the trench, nor was there any distinct separation or sand split between the two utilities. The utilities were buried significantly shallower than specified with by NJUG (industry guidelines).

Ensure safe systems of work such as risk assessments and method statements are in place and understood.
Ensure that Safe Dig Techniques are followed as per HSG47.
