SUBJECT: Swimming Pool Alert – Vacuum Vents

HSB 15

Unprotected vacuum vents in swimming pools

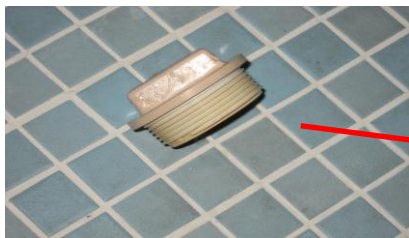
1) Vacuum vent cover

We would like to bring your attention to a recent incident which resulted in a child’s limb being “sucked” into a vacuum vent as a result of its protective cover not being replaced. The force of the suction resulted in staff having to enter the water to remove the child’s limb from the vacuum vent.

For some **cleaning processes** in swimming pools a vacuum hose is attached to a vacuum vent under the water line. By removing the vent cover (Fig.1) located on the wall of the swimming pool (Fig.2) and attaching the vacuum hose the swimming pool operators are able to vacuum up solid waste debris from the bottom of the pool through the hose and out of the pool.

All LCC Pool Operators MUST- review risk assessments, considering the consequences of vacuum vents being left turned on and un-protected. A rigorous risk assessment and safe system of work should be implemented for the use of vacuum vents to prevent a re-occurrence of a similar incident.

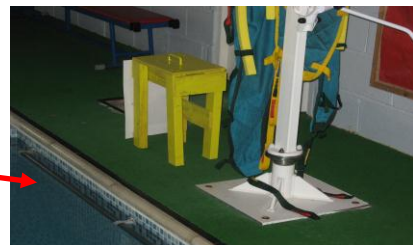
2) Vacuum “vent” cover under the water line
