## **SUBJECT:** Unsafe guttering due to snow & ice build up

ISSUE DATE: 7<sup>th</sup> Dec 2010 REF: HSA2

## **Guttering Collapse and falling icicles**

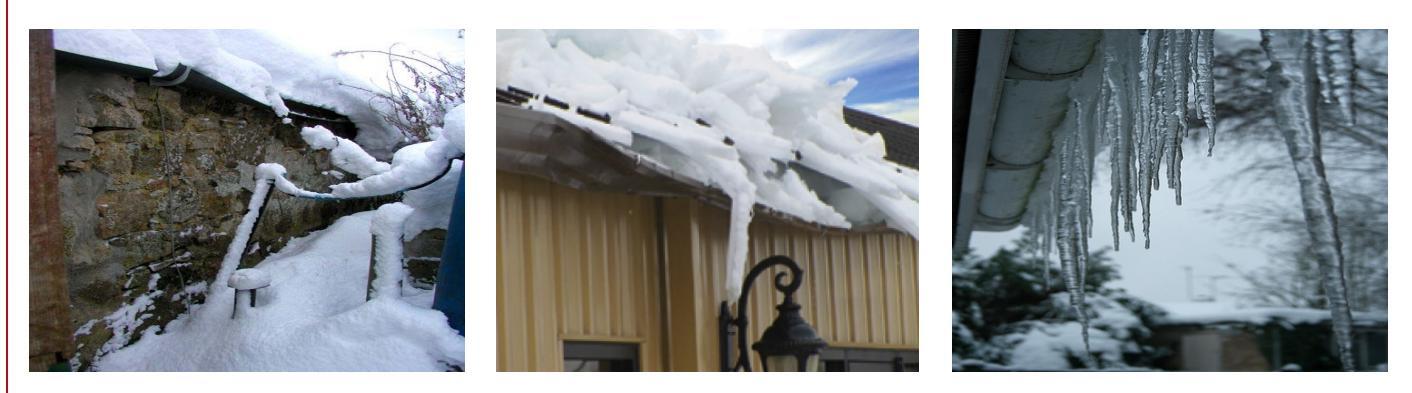
## COMPACTED SNOW IS THREE TIMES HEAVIER THAN FRESHLY FALLEN SNOW

Due to the heavy snow fall and freezing temperatures over the last week some guttering may have torn away from the building or been weakened by a thick build up of compacted snow/ice increasing the risk of them failing and falling. There is also the risk of large icicles or heavy ice/snow falling from the roof/guttering.

It is therefore essential that you assess the guttering on your building to confirm its structural safety and any overhanging and/or thick snow/ice on roofs above footpaths/doors.

The controlled removal of dangerous overhanging snow/ice may be part of a planned maintenance programme with due consideration given to a safe method of work.
