SUBJECT: The Cable Strikes Back

REF: HSB 157

What Lies Beneath

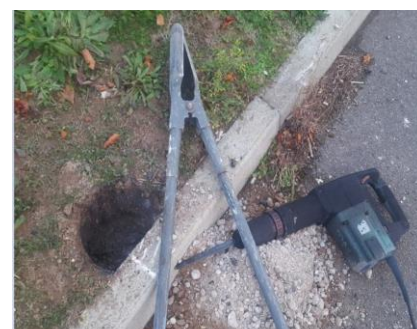
While operating the electric breaker, one of the operatives struck an 11kv electricity cable causing a large flash and engulfing him in flames. The operative sustained serious burns to his face, chest, abdomen, groin, both arms and both legs, amounting to approximately 50% total body surface area burns.

An investigation by the Health and Safety Executive (HSE) found that the company failed to source and refer to the underground services plans prior to breaking the ground to determine the location of any cables within the planned working area. They also failed to provide their operatives with cable identification equipment to further locate any cables within that area.
