Safety Alert

SUBJECT: Hoist Failure

REF: HSA25

Molift air 200 ceiling hoist

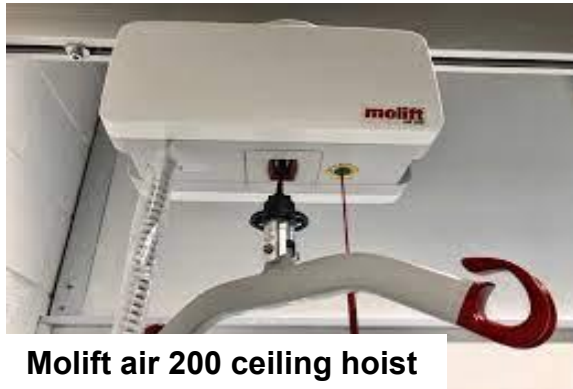
Recently a **molift air 200** ceiling hoist failed whilst in use at an LCC site.

If your staff and those we support are currently using the same model (molift air 200) of ceiling hoist, the following steps should be taken:

- If an alternative hoist is available, use it instead of the molift air 200.

If no other hoist type is available, and a molift 200 air hoist must be used, ensure that:

- A current Thorough Examination Certificate is in place.
- Only staff that have been trained in the use of Ceiling Hoists are to operate them.
- Pre use checks of the equipment are to be carried out and a record kept
